Recurring hurricanes – the Cuban experience

Disaster Prevention

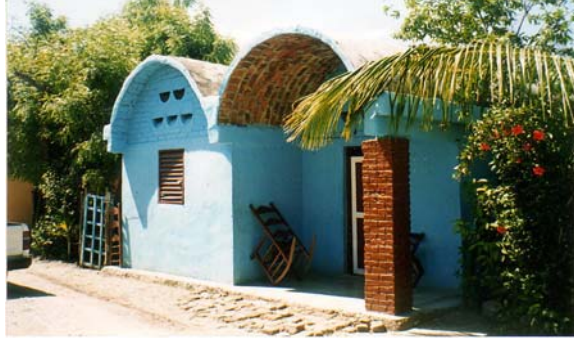
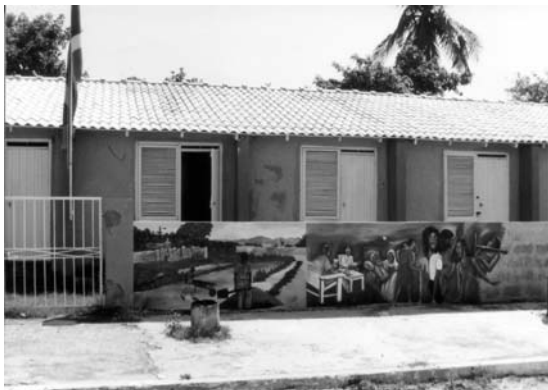
Hurricane Gilbert 1989 - Jamaica

Many roofs suffered serious damage, but the Golden Age Home in Kingston's Trench Town became a refuge for neighbors whose tin roofs had flown away. Its Micro Concrete Roof resisted well and only five tiles on the open overhang were lifted. It must be stressed that these tiles were not properly fixed as recommended, even worse, the wire loops were not nailed down!

In the Dominican Republic MCR roofs did not suffer while zinc roofs were severely damaged and the vaulted brick roofs were not affected.

In the early days of Micro Concrete Roofing (MCR) the recurring hurricanes were an important test. In Jamaica and the Dominican Republic all tiles were manufactured by local producers and sometimes placed on rudimentary support structures.

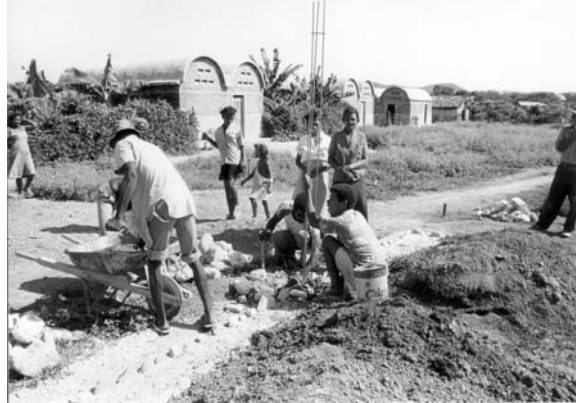
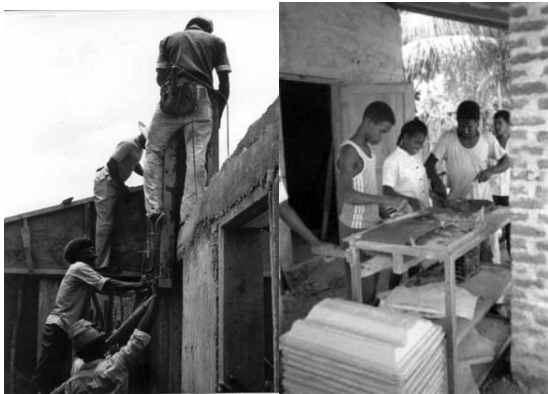
Hurricane George 1998 – Dominican Republic

The houses had no major problems and, according to some inhabitants, they did not feel anything during the hurricane. The few tiles which did fly away was because they had not been fastened to the wooden understructure.

The technologies were determined by the availability of raw materials: foundations of rocks and low grade concrete (cyclop concrete), walls of cyclop concrete, adobe or fired bricks, and roofs with Micro Concrete Roofing tiles (MCR) or brick vaults. All technologies were new to the villagers; traditional construction used palm boards for walls and thatch or zinc sheets for roofing. An intensive education program for future masons was always the base for action.

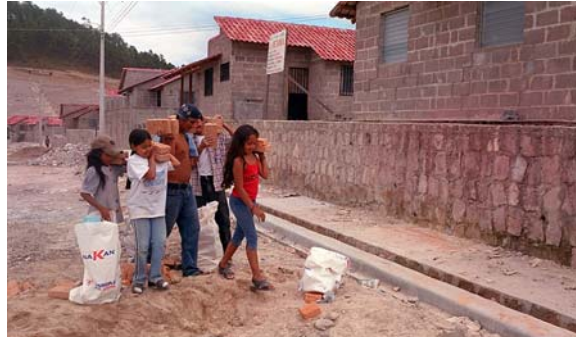
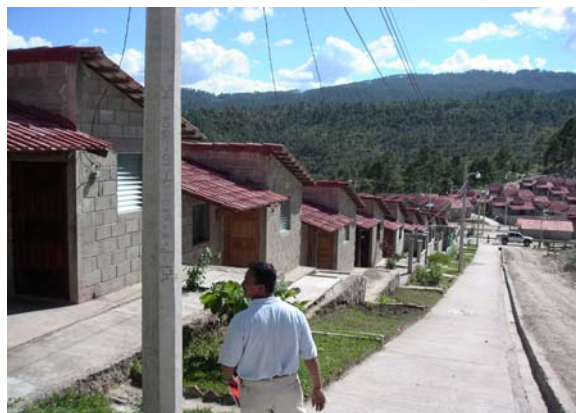
EcoSouth partner CIDEM dispatched a town planner to Honduras and, together with the national planning board and the committee of the future house owners, he conceived an innovative settlement design, limiting earth movements to a minimum and creating interesting areas for the 317 projected houses.

The only materials available on site were clay, sand and rocks. Due to the massiveness of the project and the small plots clay was not a viable choice for walls. Thus, EcoVide produced hollow concrete blocks and MCR tiles on site at costs below commercial materials, although market salaries were paid and all sand, gravel and cement had to be transported to the site.

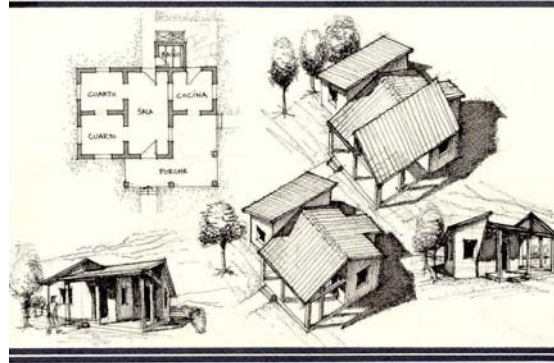
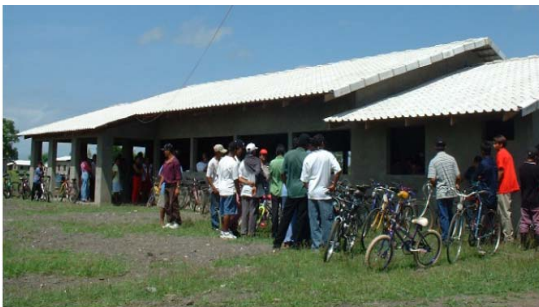
For the houses, the challenge was to achieve a basic design that allowed the houses to look different. This was accomplished through various ways of treating the roofs. A participatory approach allowed beneficiaries to express how they would like their future homes, and designs emerged that became reality in the houses the people built under the guidance of Grupo Sofonias.

Rocks, fine sand and clay are the raw materials available locally; everything else must be transported from afar, crossing a river on a ferry. The technology chosen was foundations and walls of cyclop concrete with partial substitution of Portland cement by puzzolana. Clay was no option as a certain risk of inundation could not be totally excluded. Micro Concrete Roofing tiles (MCR) were produced on site.

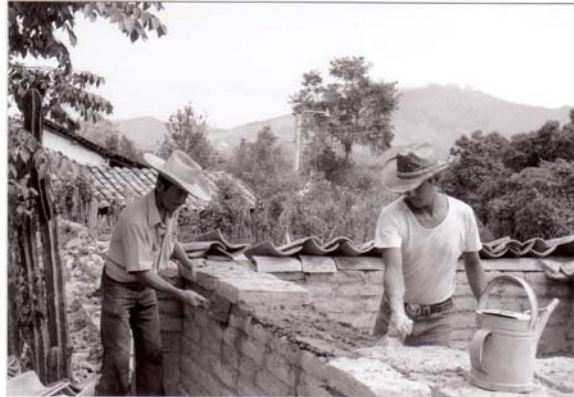
The technical evaluation compared the results to the instructions in the technical manual produced by Caritas Guatemala in 1976. This manual has been widely used as a reference document in many adobe projects throughout Latin America, and was based on a UN-sponsored investigation after the 1970 Peruvian earthquake. Learning from experiences cannot be underestimated.

This project concentrated on the Department of Baja Verapaz, a hard hit area somewhat off the beaten track in the center of the country....A team of adobe-builders was trained and a total of 150 houses were built in guided self-help in dozens of outlying villages and in the neighborhoods of the small towns..... The condition of the 24 year old houses generally is good.....The differences between them are due to different degrees of maintenance and differences in their location....The evaluation team came to the conclusion that it is possible to build houses with traditional clay technologies in seismic zones, if the necessary improvements are made.

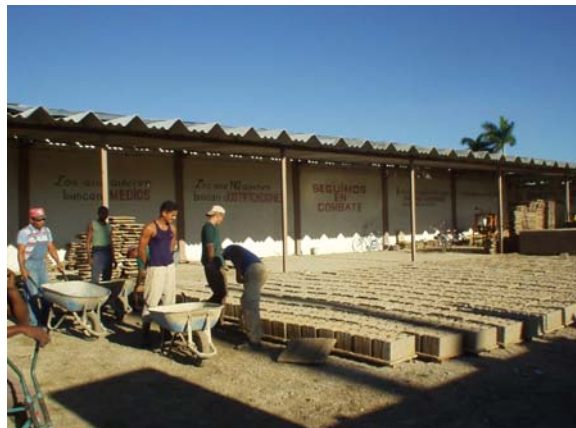
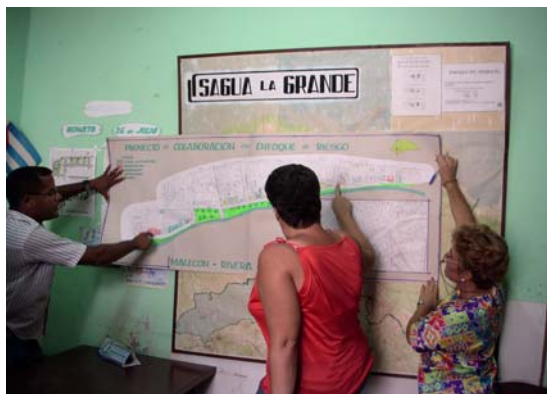
People in the town of Isabela remember when Hurricane Michelle whipped through with winds up to 280km/hour, and destroyed many buildings. However, 21 families already had Micro Concrete Roofing through and one inhabitant said that in the past each time a hurricane passed she lost her roof. Now, with her new roof, no tiles broke or moved during Hurricane Michelle and she feels secure.
