SKAT/RAS CASE STUDY SERIES DOSSIER: EDUCATIONAL FACILITIES EF2, 2000

Rural School Construction in Southern Nicaragua

FUNCTION	School buildings for basic education
LOCATION	Southern Nicaragua
PROMOTER	Ministry of Education, Nicaragua
ARCHITECTS	Kurt Rhyner / Emiliano Armira / Marcelino Castro
PROJECT IMPLEMENTATION	Grupo Sofonias
YEARS OF CONSTRUCTION	1980 - 1990

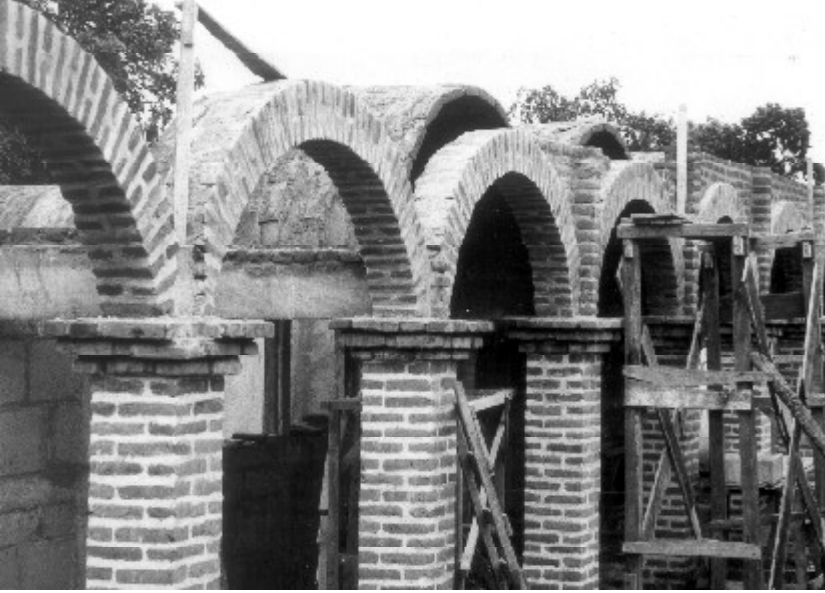
Left top:
Building colonial façades in 1985

Left bottom:
Cut quarrystones are the locally available material in Carazo

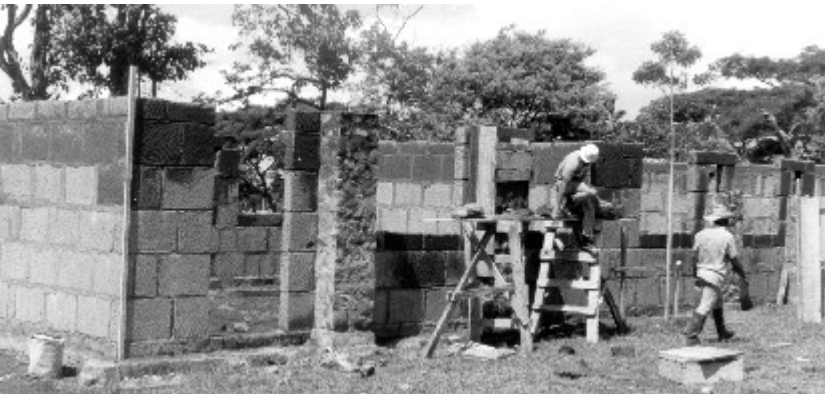
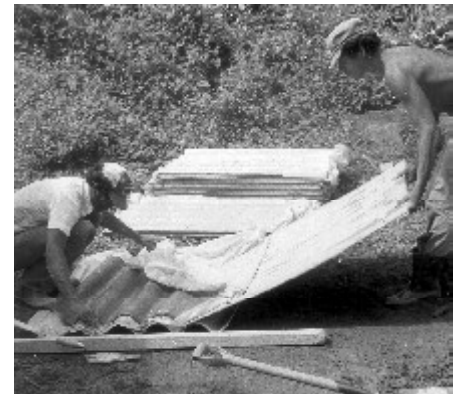
Below:
Fibre concrete sheets were produced on site and later replaced by MCR tiles

After the homemade fibre-concrete sheets proved to be a failure (some sheets cracked after one or two years on the roof), the project turned towards micro-concrete tiles or vaults made with fired clay bricks. The

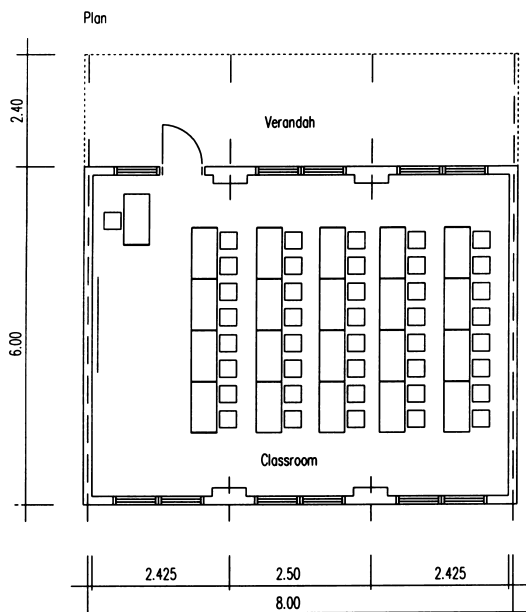
**Legend:**

- 1 Brick vault
- 2 ventilation blocks
- 3 reinforced concrete beam
- 4 bricks or stone
- 5 reinforced concrete beam
- 6 concrete floor
- 7 foundation
