November 1998

HURRICANE GEORGE – REPORTS FROM THE FIELD

**Victor Martinez, EcoVide
Martin Melendez, Grupo Sofonias**

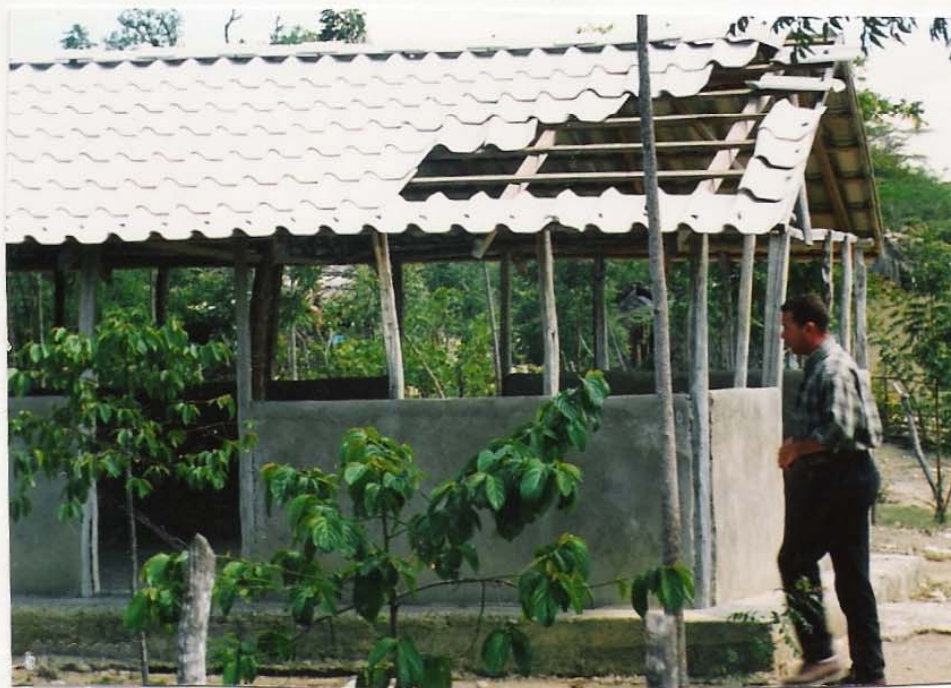
the few tiles which flew away had not been fastened.....

Houses built by Grupo Sofonias did not have major problems and, according to some of the inhabitants, they did not feel anything during the hurricane. The few tiles which did fly away was because they had not been fastened to the wooden understructure. This was a surprise insofar as under such conditions we would have expected all to fly away.
